Effects on Microstructural and Mechanical Performance Characterizations of IN625 & AISi10MG from Build Interruptions

Test Results from LPBF Build Interruptions Provide Understanding of Impact on Properties

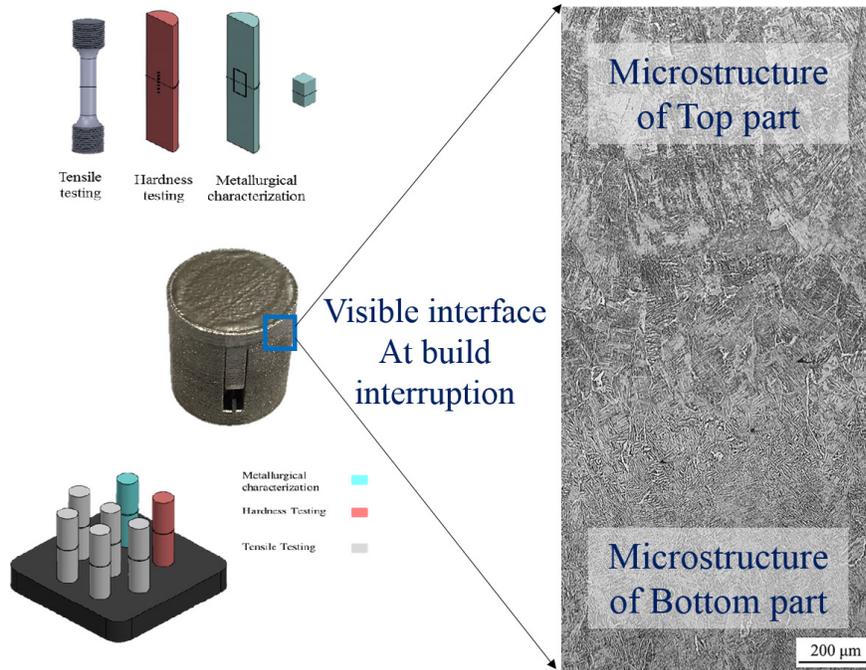
Data matrix related to tensile testing, hardness testing, and metallurgical characterization between control specimens (no interrupt) and build interrupt specimens for various build time delays in AISi10Mg and IN625.
