# SUCCESS STORY

Mechanical testing, metallography and CT scanning, and in-situ monitoring used to quantify effects of build interruptions for In-718, Al10SiMg, and Ti6-4.

# Build interruptions had no significant effect on In-718 and Al10SiMg, yet a small decrease in tensile strength for Ti6-4 was realized

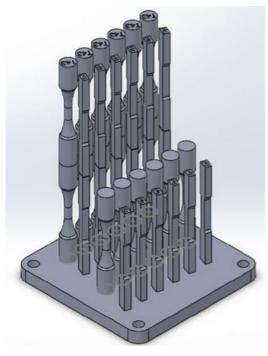
Build interruption tensile samples

Tensile testing was performed at the OSU Center for Design and Manufacturing Excellence (CDME) where specimens were pulled until failure at a rate of 0.1mm/min. A fatigue specimen from each build was taken and sent for metallography, and the reduced section was sectioned and polished. During each build, tomography and recoater data were collected as part of the in-situ monitoring analysis.
