## Multi-laser Power Bed Fusion Process Achieves 47% Reduction in Build Speed

3014 MAMLS Evaluation of Defects in Metal Laser Powder Bed Fusion (LPBF) AM using Multiple Lasers

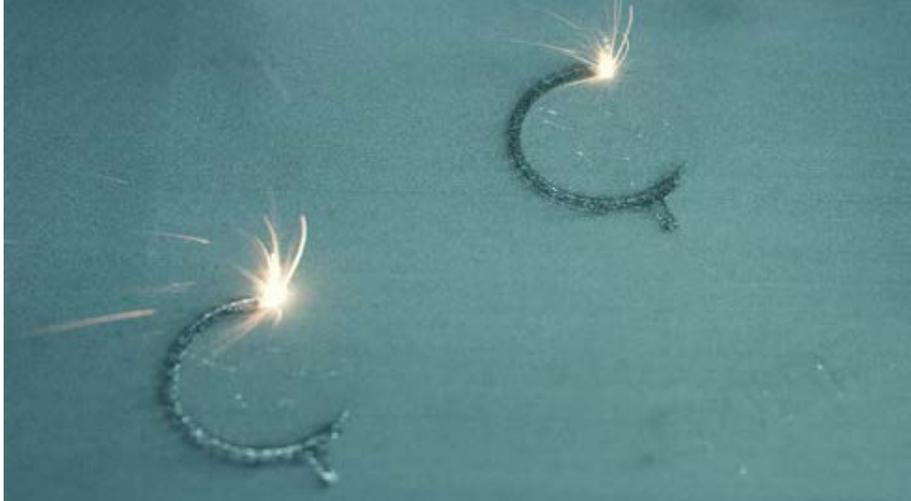
*Image of laser powder bed fusion with two lasers during printing (note effluent from each melt pool).*
