# Evaluation of Defects in Metal Laser Powder Bed Fusion (LPBF) Additive Manufacturing Using Multiple Layers

EQUIPMENT:  
Concept Laser  
M2

MATERIAL:  
IN 718

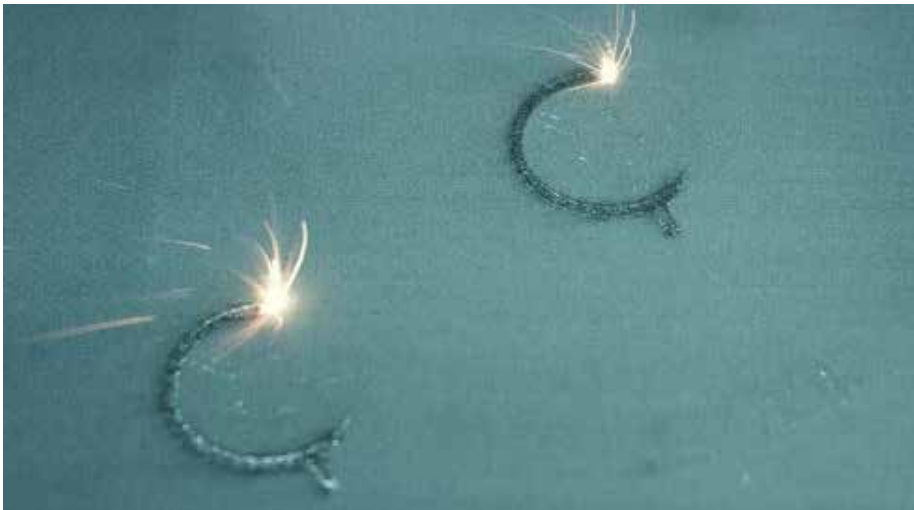
Image of laser powder bed fusion with two lasers during printing (note effluent from each melt pool).
